COASTLINE CHANGE ANALYSIS ON BALI ISLAND USING SENTINEL-1 SATELLITE IMAGERY

Suhendra^{1*}, Christopher Ari Setiawan¹, Teja Arief Wibawa¹, Berta Berlian Borneo¹

¹Institute for Marine Research and Observation - Ministry of Marine Affairs and Fisheries

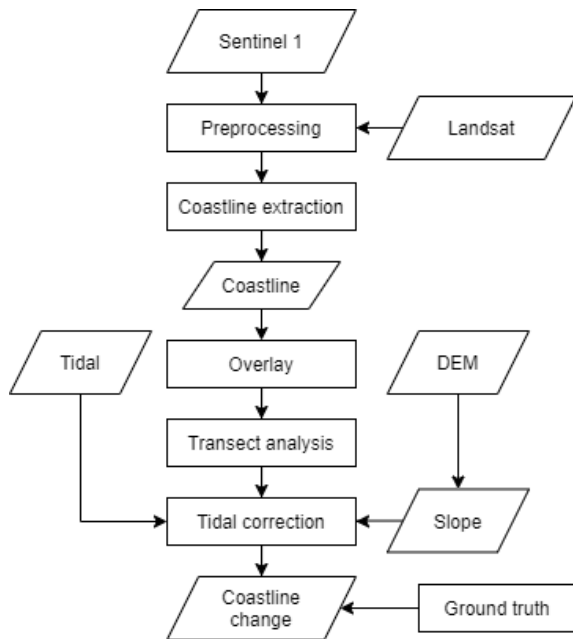
Figure 2-2: Research flowchart

The coastline extraction method from the Sentinel-1 images included preprocessing, segmentation and vectorisation. SeNtinel Application Platform (SNAP) software was used to preprocess the Sentinel-1 images in order to obtain radiometrically- and geometrically- corrected images for better interpretation. Mosaicking of the Sentinel-1 data was performed in order to cover the whole area. The choice of VH polarisation and the conversion of decibel bands were the main factors that ensured that the SAR images had a clearer contrast between land and sea features (Truckenbrodt et al., 2019; Zollini et al., 2020).

The next step was segmentation, which aimed to separate land and sea as represented by binary images using the Otsu image thresholding method (Otsu, 1979). In the final step, vectorisation was performed to obtain the coastline features in the form of vector data. The coastline extraction method on the Landsat images was conducted using the NDVI (Normalized Difference Vegetation Index) and Tasseled Cap transformation method (Kauth & Thomas, 1976).

The transect method was employed to analyse the coastline changes (Vos, Splinter, Harley, Simmons, & Turner, 2019). The 200 m transect (100 m landward and 100 m seaward) along the border of Bali Island had a distance of 100 m between the transects. Prior to calculating the coastline changes, the length of each coastline was calculated from the tip of the transect perpendicular offshore. The distance between the oldest and the youngest coastlines for each transect was calculated. The rate of coastline change was calculated by dividing the distance of coastline change by the elapsed time between the oldest and most recent coastline (Himmelstoss, Henderson, Kratzmann, & Farris, 2018). The categories of coastline change rates are shown in Table 2-1.

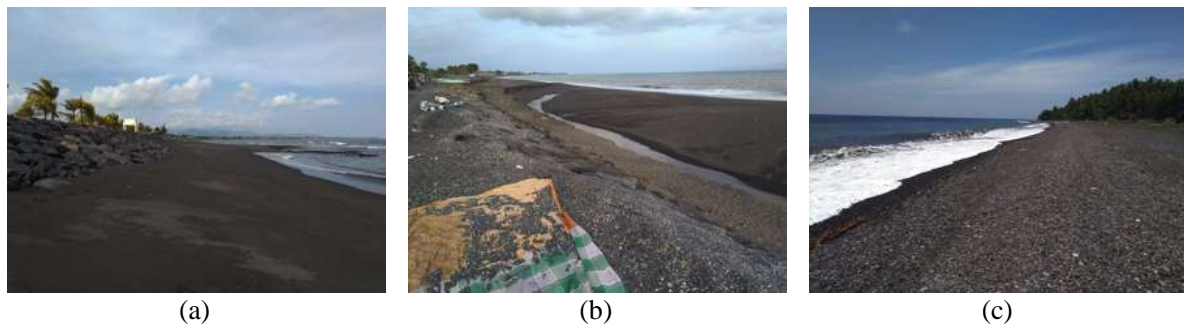
Figure 3-5: Survey points: a) Point 1, located west of Lebih Beach, Gianyar; b) Point 2, located west of Siyut Beach, Gianyar; c) Point 3, located at Sukalegawa Beach, Karangasem

Point 1 was located west of Lebih Beach, Gianyar and was characterised as a sandy beach (Figure 3-5a). According to interview with local fisherman, there were frequent abrasions on Lebih Beach from the 1980s to the 2000s. As preventive action, an embankment was built along the coastal area. Point 2 was located west of Siyut Beach, Gianyar. This had similar conditions to Point 1 (Figure 3-5b), but in this case the Jeh Jinah river was the cause of abrasion. Point 3 was located at Sukalegawa Beach, Karangasem. This was characterised as a rocky beach (Figure

3-5c) and used to be a base for local fishermen from the 1990s to the 2000s. When the coastal conditions were not severely eroded, it was also used as a salt pond area. According to the ground truth, there were high waves at all three sites.

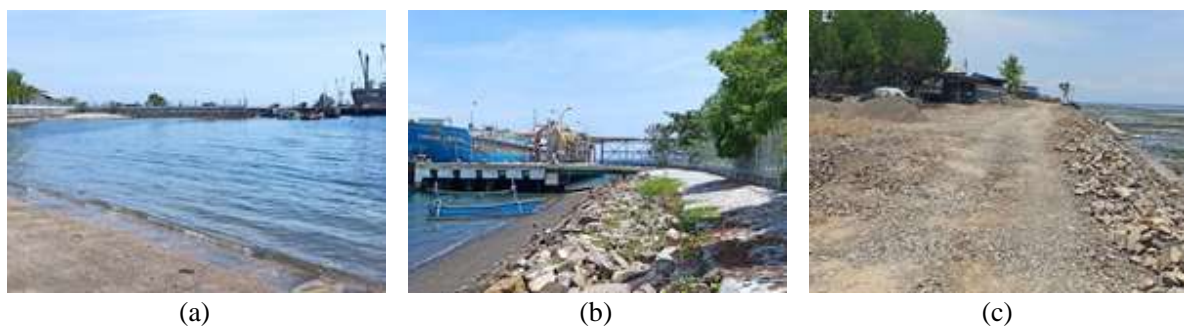
Figure 3-6: Survey points: a) Point 1, located at Celukan Bawang Port; b) Point 2, located north of Tonasa Cement Factory; c) Point 3, located at Penyabangan Beach

Three survey points in Buleleng Regency were Celukan Bawang Port, Tonasa Cement Factory and Penyabangan Beach (Figure 3-6). Points 1 and 2 were located in Celukan Bawang Port. Celukan Bawang is the port which is organized by Pelindo 3. The interview in Celukan Bawang Port was conducted with an employee of Pelindo 3, while that in Penyabangan Beach was conducted with the owner of the pond around the survey site. Based on the results of the interview with the Pelindo 3 employee, there has been abrasion around Celukan Bawang Port, but this has stopped

because of the construction of the port. In addition, there has been accretion around Tonasa Cement Factory, that has occurred due to the construction of the factory itself. The interview with the pond owner revealed that there was a temple called Pura Penyabangan which had to

be moved three times due to the abrasion of Penyabangan Beach. Despite the abrasion, local residents have been reconstructing the area since 2015, so the data analysis from 2015 – 2020 shows that the area has changed into one of accretion.
